# Meeting customer requirements for ROEBEL cable for ac applications

# Dependence of $I_c$ with different angles of current flow evaluated for ROEBEL application

# Meeting customer performance requirements for joints: mechanical robustness proven in *Production Mode*

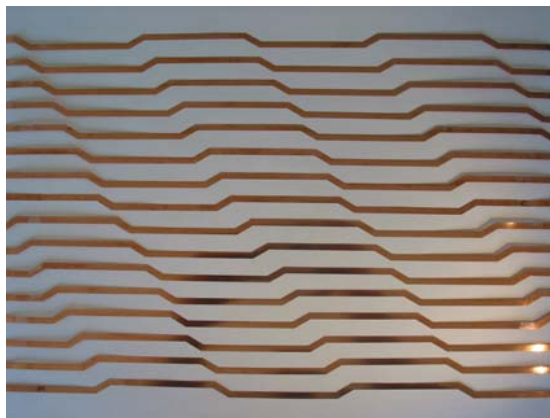
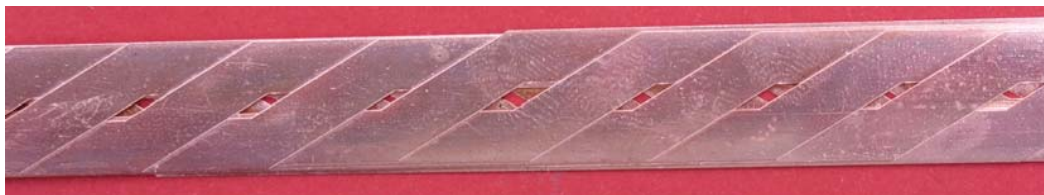
ROEBEL cable made by Forschungszentrum Karlsruhe with SuperPower® 2G HTS Wire

No failure, no delamination

Only 3% loss in current from conductor to ROEBEL cable

Cable engineering current density = 11,300 A/cm<sup>2</sup>

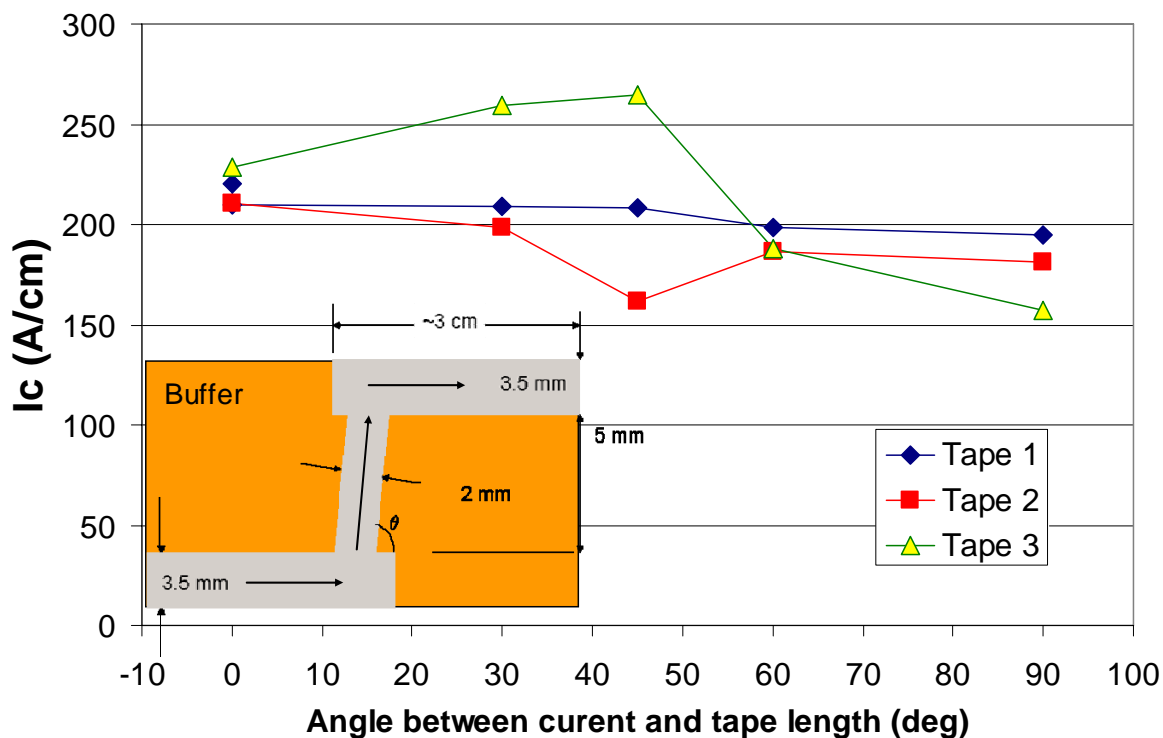
12 mm wide 2G wire patterned in multiple segments for measurements of  $I_c$  at different angles of current flow

No systematically discernible  $I_c$  reduction in intermediate angles that are employed in ROEBEL conductor fabrication

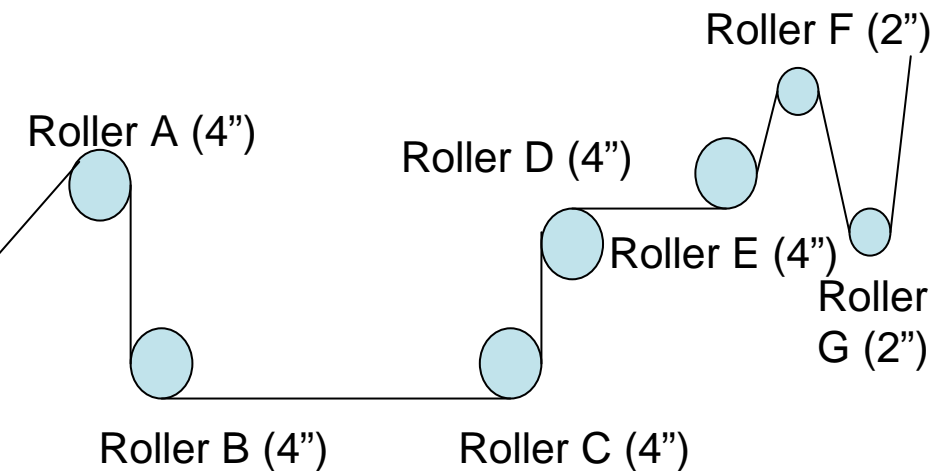
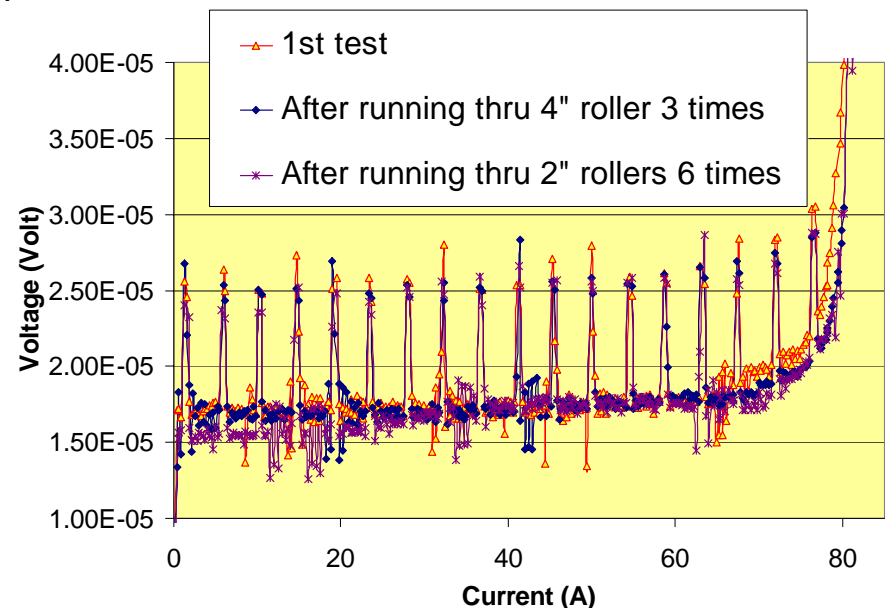
- At ASC 2006, we reported good performance of joints made in test lab.
- A customer required 1,200 m of 2G wire with 11 joints for a coil application. The Ic of entire wire length and resistance of all joints had to be *tested after joining*
- A production operation was developed to make consistently high-quality joints
- Also, the mechanical robustness of joints had to be established since the joined wire had to be moved through 4" and 2" diameter rollers in the 5 m transport Ic measurement rig at a speed up to 400 m/h

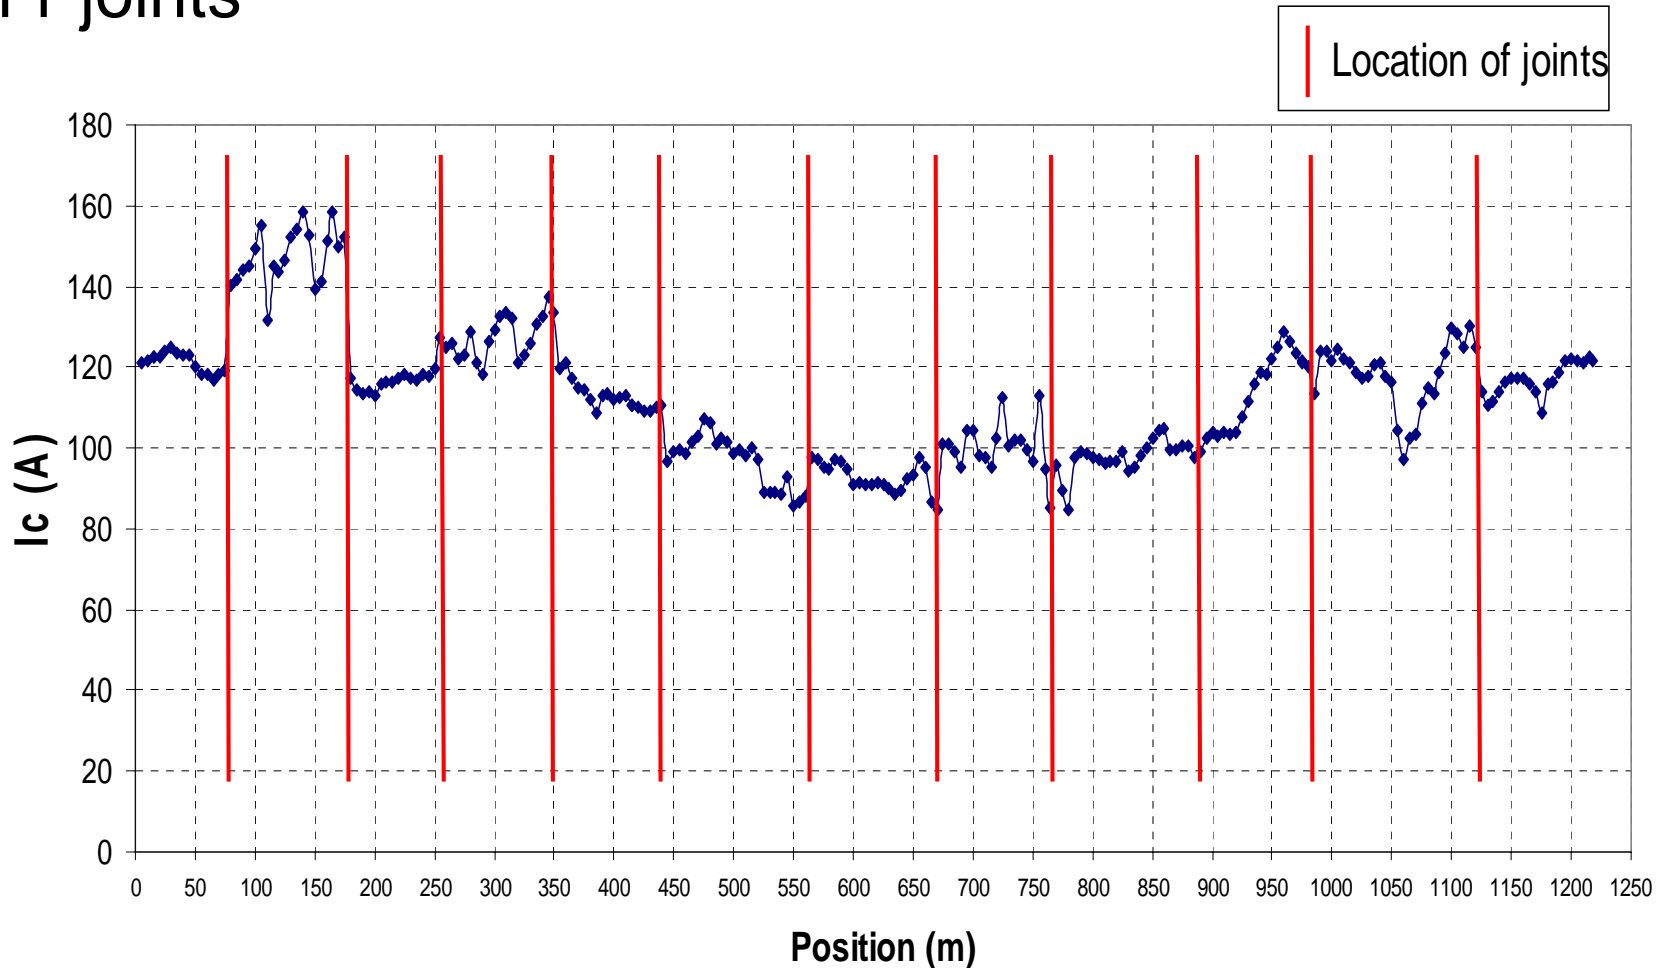
# Ic measured every 5 meters over 1,218 m of wire with 11 joints

Arrangement of the 12 segments along the length was decided based on communication with customer so that the Ic profile would fit the coil winding requirements

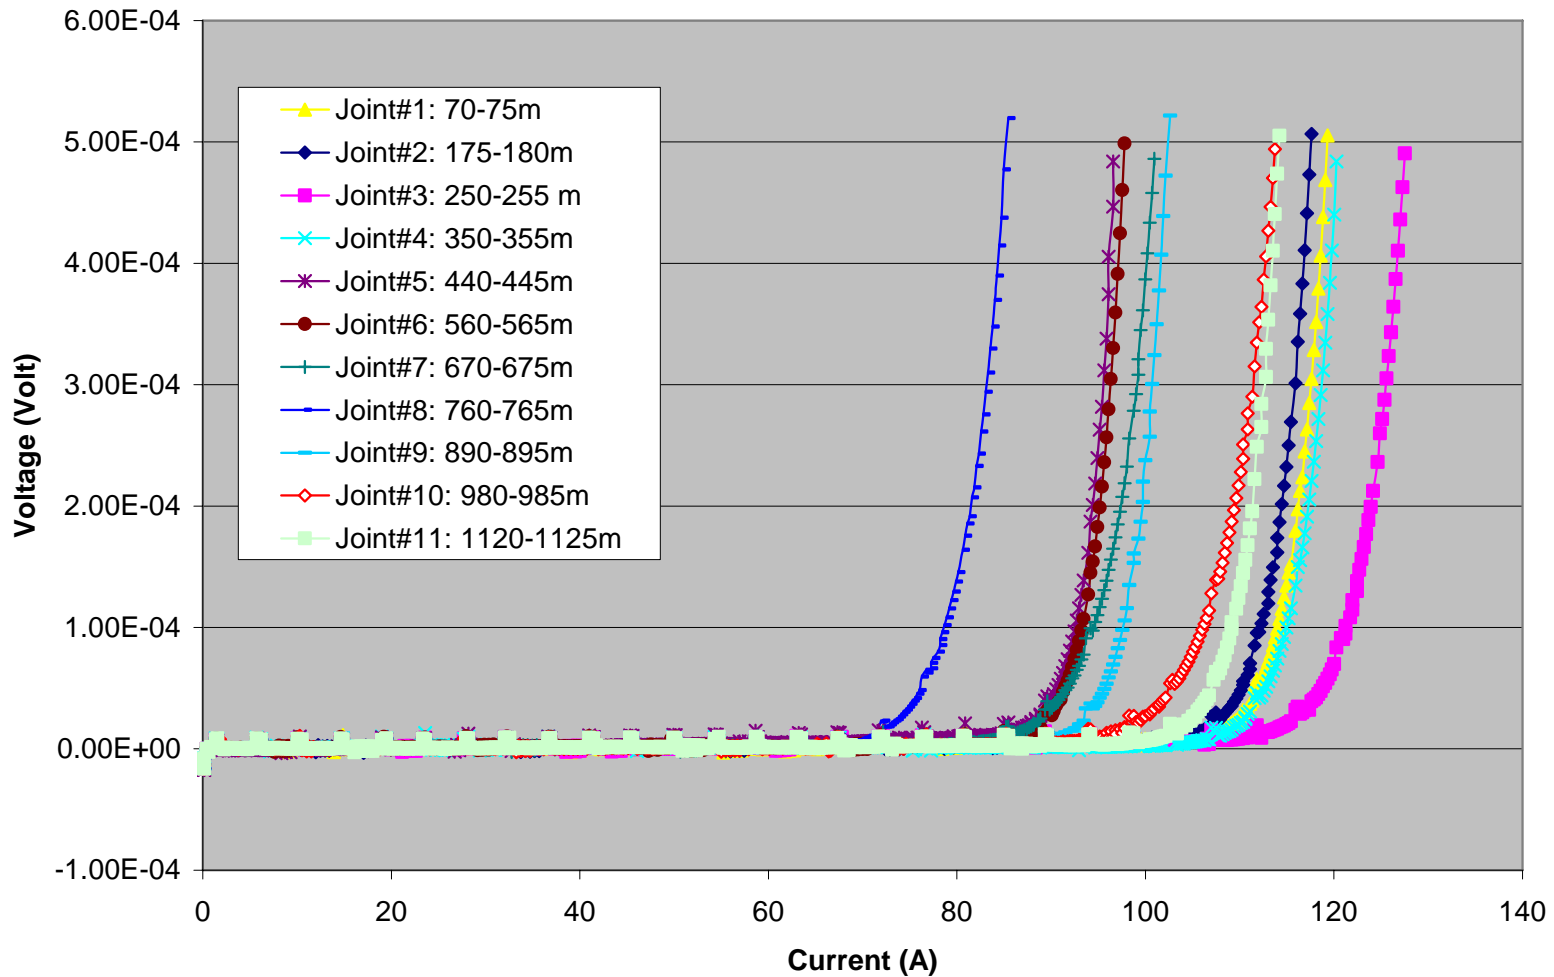
# I-V curves of the 11 sections containing the joints

All 11 joints show smooth transition at their respective  $I_c$

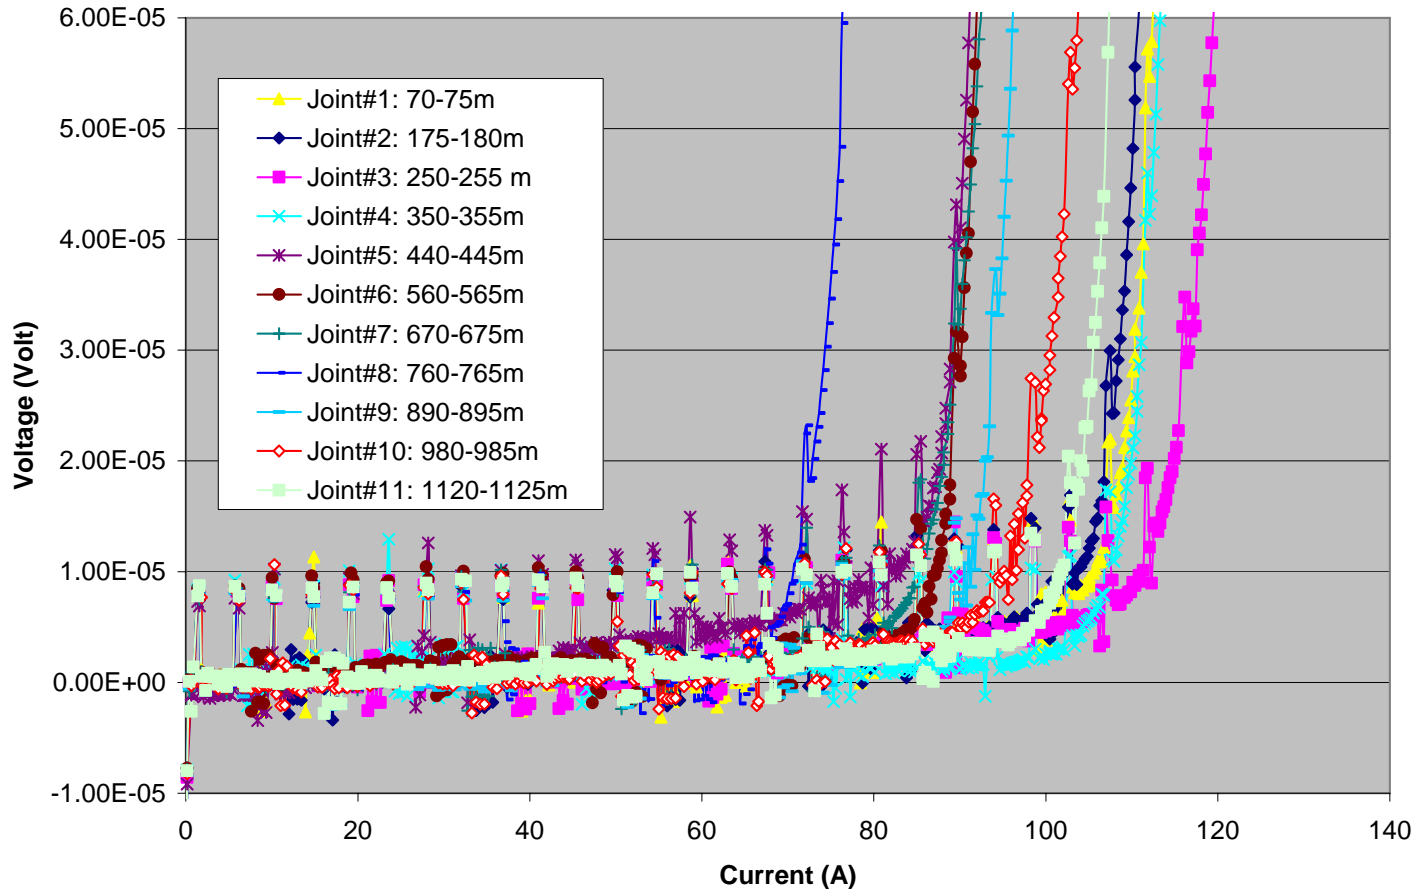
# Excellent resistance measured in all joints

All but one of the joints showed a resistance around **33 nΩ**, One joint showed a resistance of 100 nΩ, still within limit

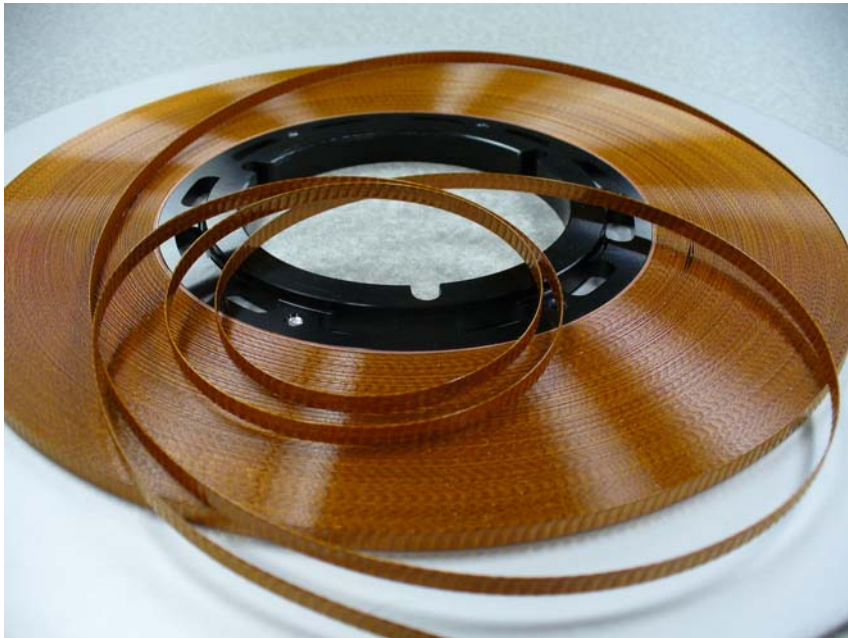
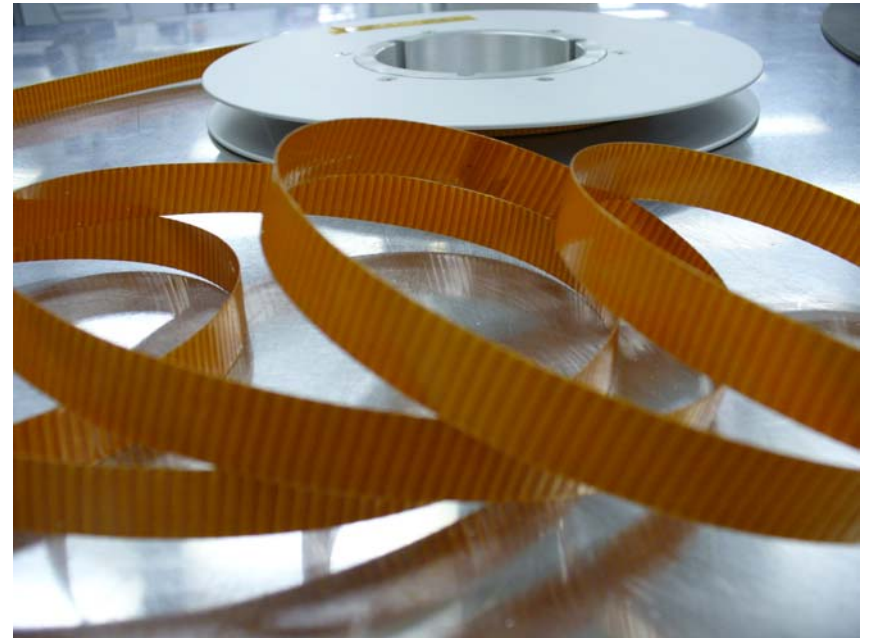
- Several customers, primarily for coil applications, required insulated 2G wire
- After evaluating a number of vendors, we procured a system for in-house fabrication of insulated wire
- System in place and being used for both 12 and 4 mm wide wire

- Preliminary test showed no breakdown at 1000 V with 0.0025 mm polyimide film
- Deliveries of insulated wire already being made.
