Meeting customer requirements for ROEBEL cable for ac applications

Meeting customer performance requirements for joints: mechanical robustness proven in *Production Mode*

Customer-driven development of insulated wire

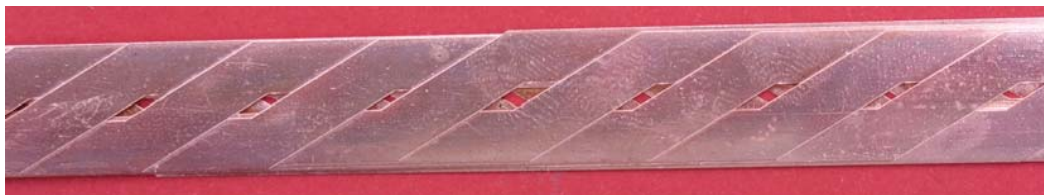
ROEBEL cable made by Forschungszentrum Karlsruhe with SuperPower® 2G HTS Wire

No failure, no delamination

Only 3% loss in current from conductor to ROEBEL cable

Cable engineering current density = 11,300 A/cm²

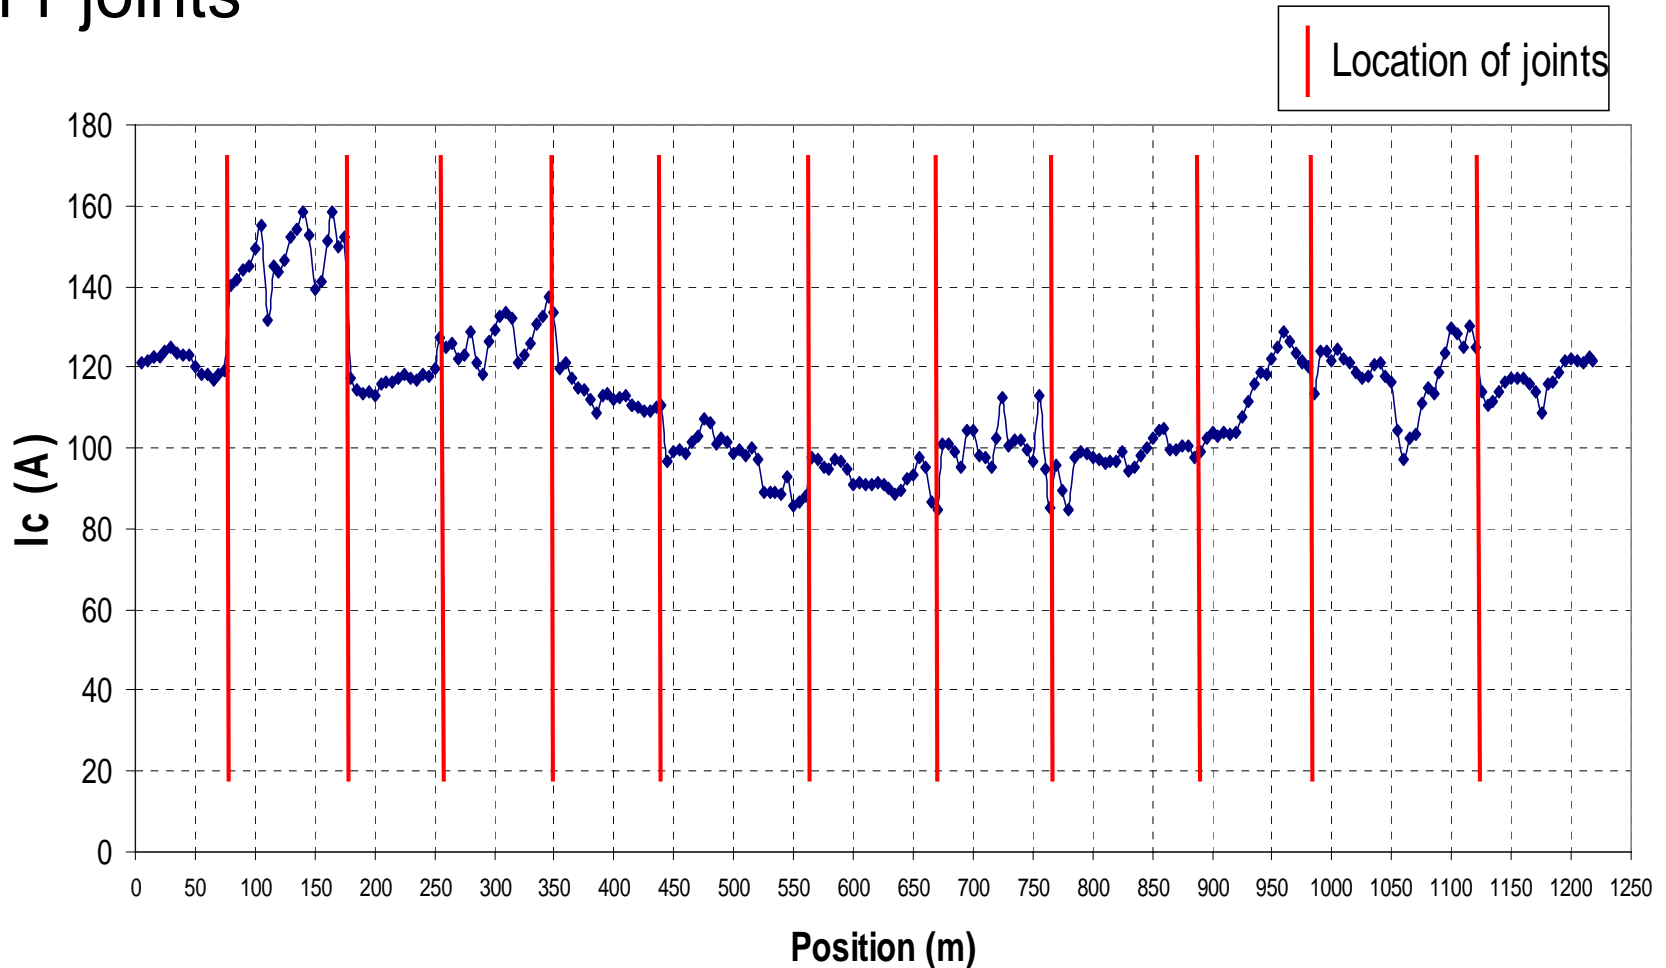
Ic measured every 5 meters over 1,218 m of wire with 11 joints

Arrangement of the 12 segments along the length was decided based on communication with customer so that the Ic profile would fit the coil winding requirements

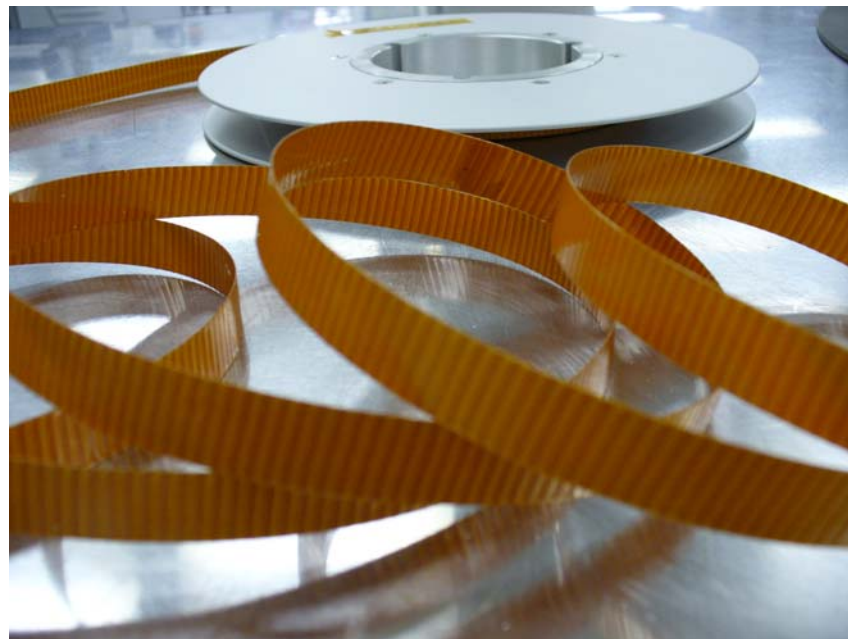
- Several customers, primarily for coil applications, required insulated 2G wire
- After evaluating a number of vendors, we procured a system for in-house fabrication of insulated wire
- System in place and being used for both 12 and 4 mm wide wire

- Preliminary test showed no breakdown at 1000 V with 0.0025 mm polyimide film
- Deliveries of insulated wire already being made.
