Meeting customer requirements for ROEBEL cable for ac applications

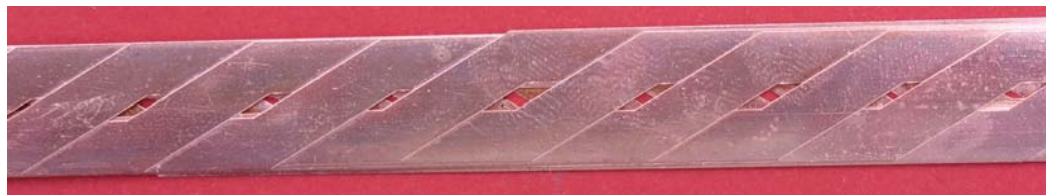
ROEBEL cable made by Forschungszentrum Karlsruhe with SuperPower® 2G HTS Wire

No failure, no delamination

Only 3% loss in current from conductor to ROEBEL cable

Cable engineering current density = 11,300 A/cm²

- ROEBEL cable is a known approach to produce low ac loss, high current conductor/cable
- Conductor exposed to severe mechanical cutting at sharp angles

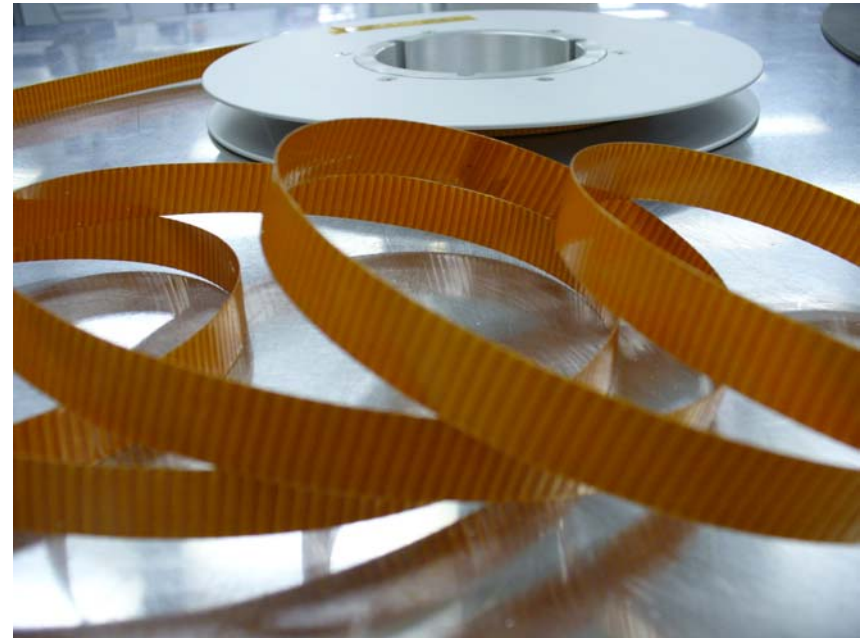
- Several customers, primarily for coil applications, required insulated 2G wire
- After evaluating a number of vendors, we procured a system for in-house fabrication of insulated wire
- System in place and being used for both 12 and 4 mm wide wire

- Preliminary test showed no breakdown at 1000 V with 0.0025 mm polyimide film
- Deliveries of insulated wire already being made.
