Meeting customer requirements for ROEBEL cable for ac applications

Meeting customer performance requirements for joints: mechanical robustness proven in *Production Mode*

Customer-driven development of insulated wire

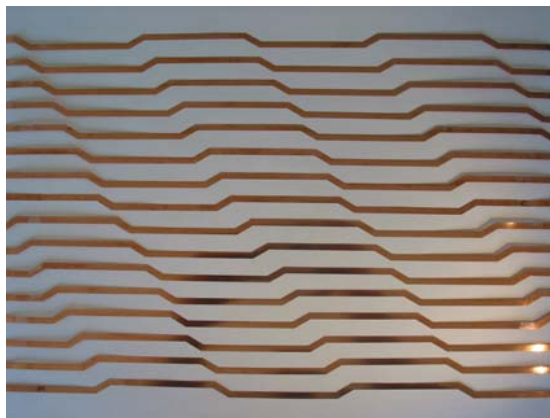
ROEBEL cable made by Forschungszentrum Karlsruhe with SuperPower® 2G HTS Wire

No failure, no delamination

Only 3% loss in current from conductor to ROEBEL cable

Cable engineering current density = 11,300 A/cm²

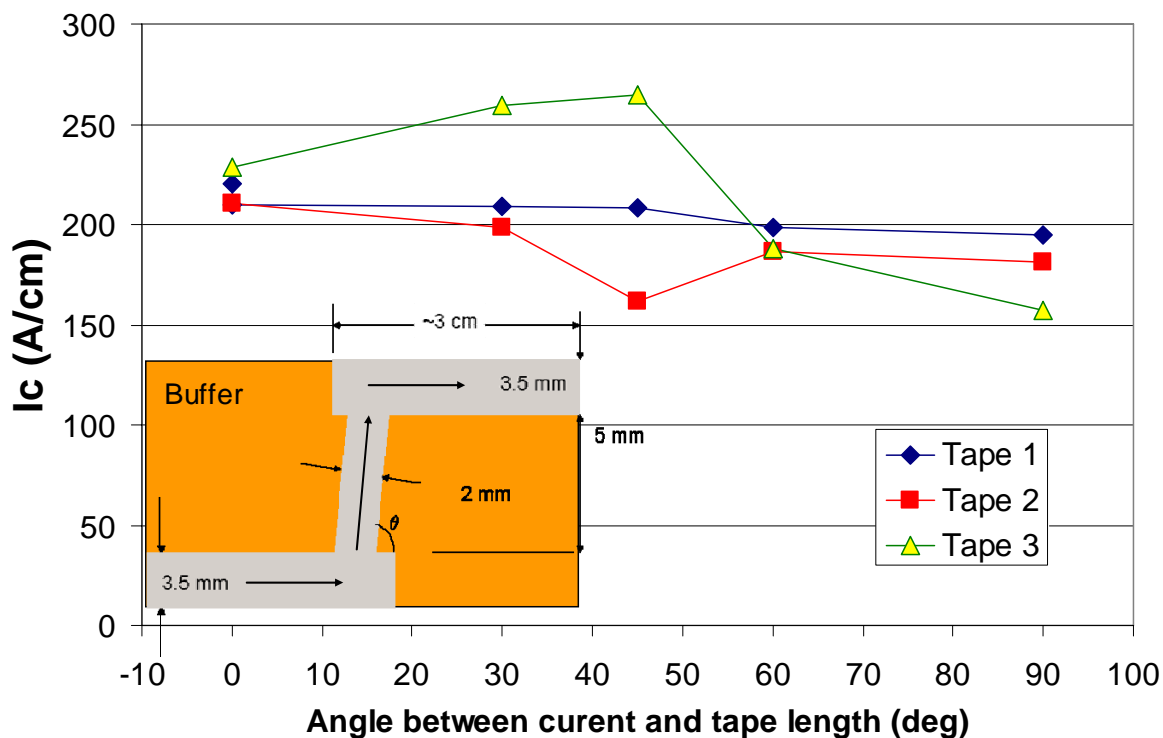
12 mm wide 2G wire patterned in multiple segments for measurements of I_c at different angles of current flow

No systematically discernible I_c reduction in intermediate angles that are employed in ROEBEL conductor fabrication

Dependence of I_c with different angles of current flow evaluated for ROEBEL application

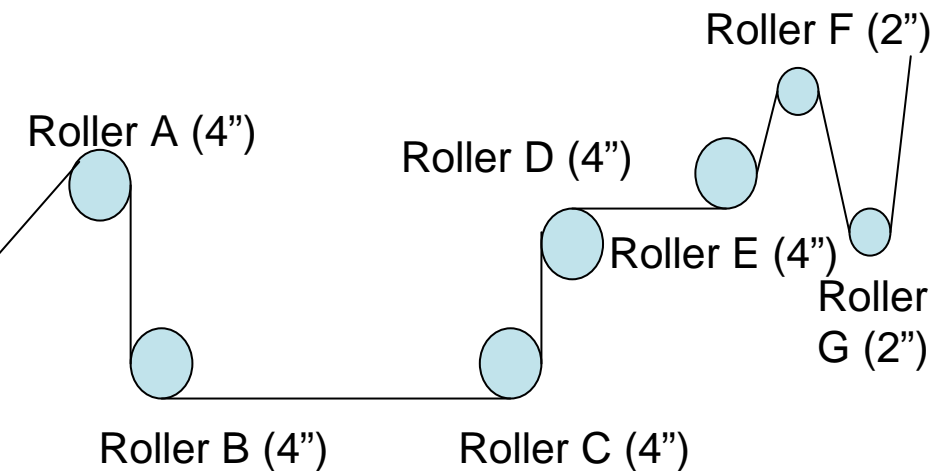
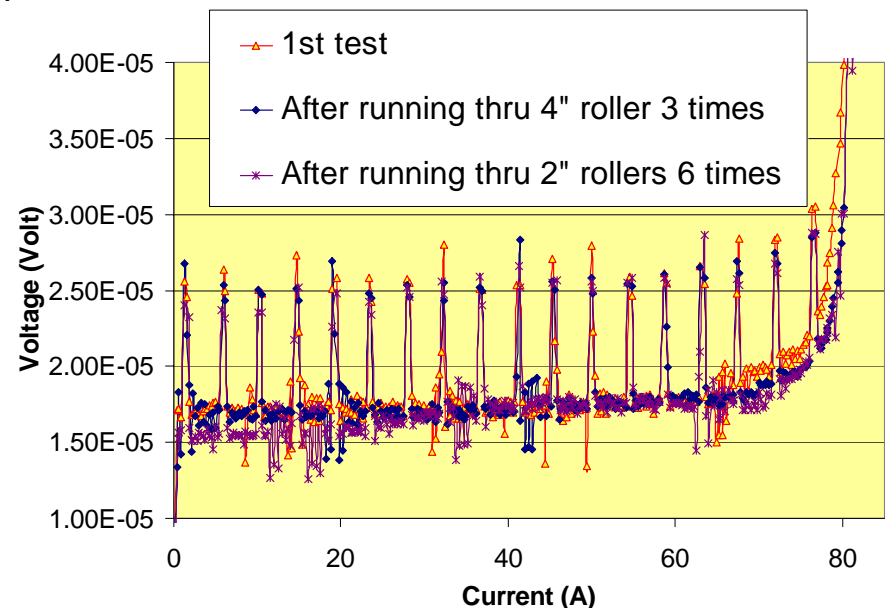
- At ASC 2006, we reported good performance of joints made in test lab.
- A customer required 1,200 m of 2G wire with 11 joints for a coil application. The Ic of entire wire length and resistance of all joints had to be *tested after joining*
- A production operation was developed to make consistently high-quality joints
- Also, the mechanical robustness of joints had to be established since the joined wire had to be moved through 4" and 2" diameter rollers in the 5 m transport Ic measurement rig at a speed up to 400 m/h

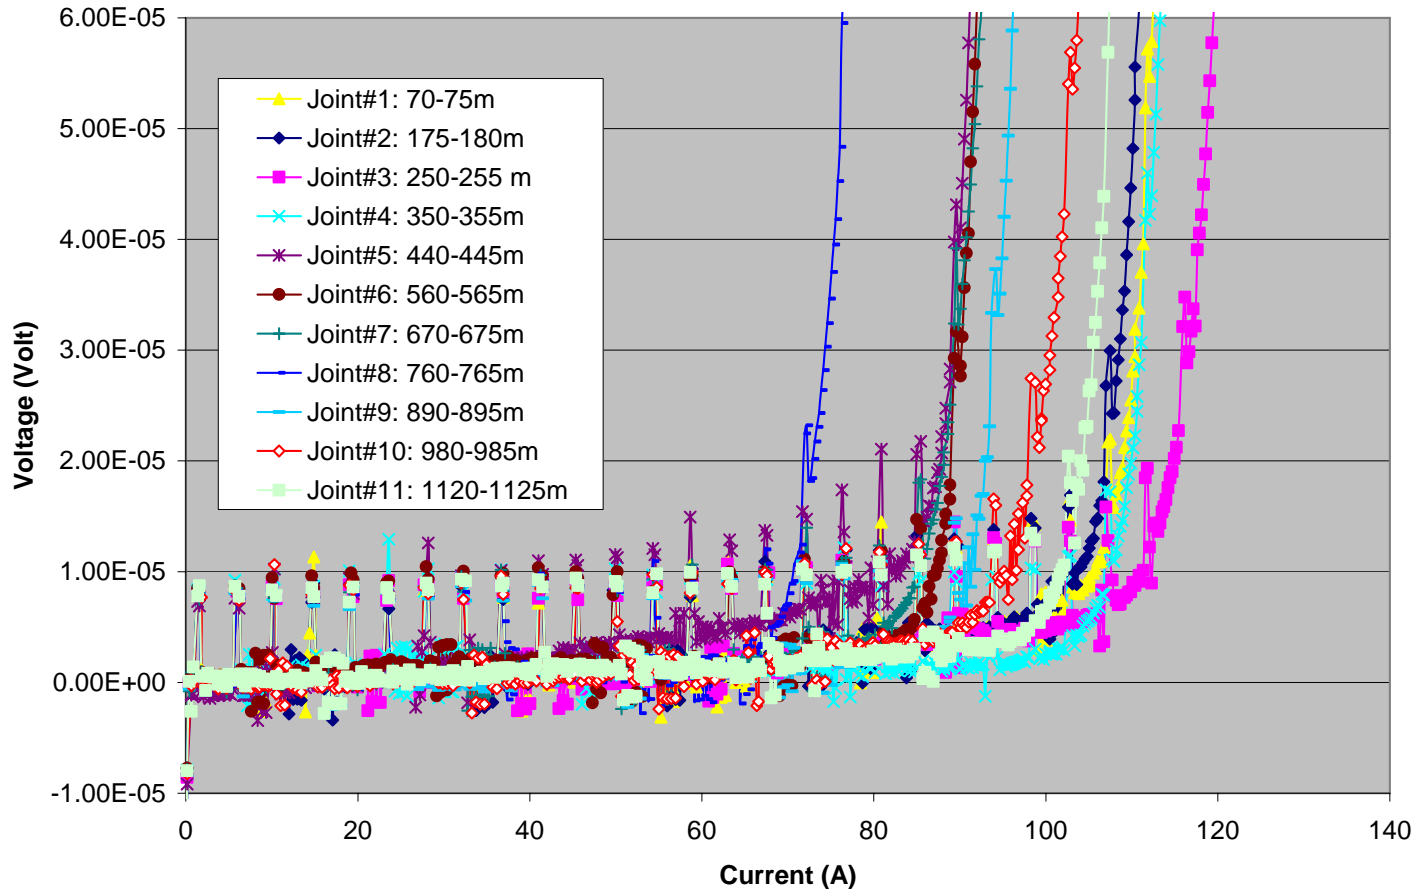
Excellent resistance measured in all joints

All but one of the joints showed a resistance around **33 nΩ**, One joint showed a resistance of 100 nΩ, still within limit
