Meeting customer requirements for ROEBEL cable for ac applications

Meeting customer performance requirements for joints: mechanical robustness proven in *Production Mode*

Customer-driven development of insulated wire

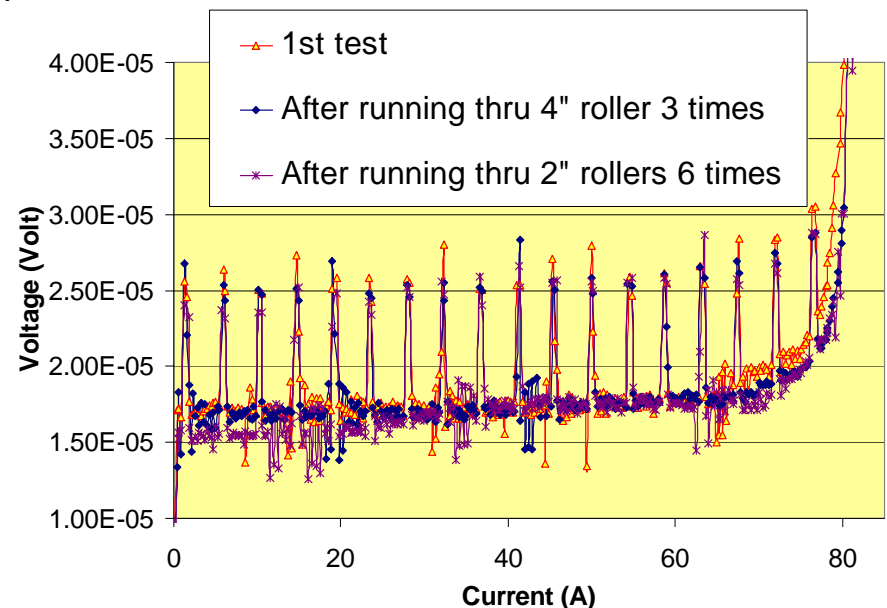
- At ASC 2006, we reported good performance of joints made in test lab.
- A customer required 1,200 m of 2G wire with 11 joints for a coil application. The Ic of entire wire length and resistance of all joints had to be *tested after joining*
- A production operation was developed to make consistently high-quality joints
- Also, the mechanical robustness of joints had to be established since the joined wire had to be moved through 4" and 2" diameter rollers in the 5 m transport Ic measurement rig at a speed up to 400 m/h

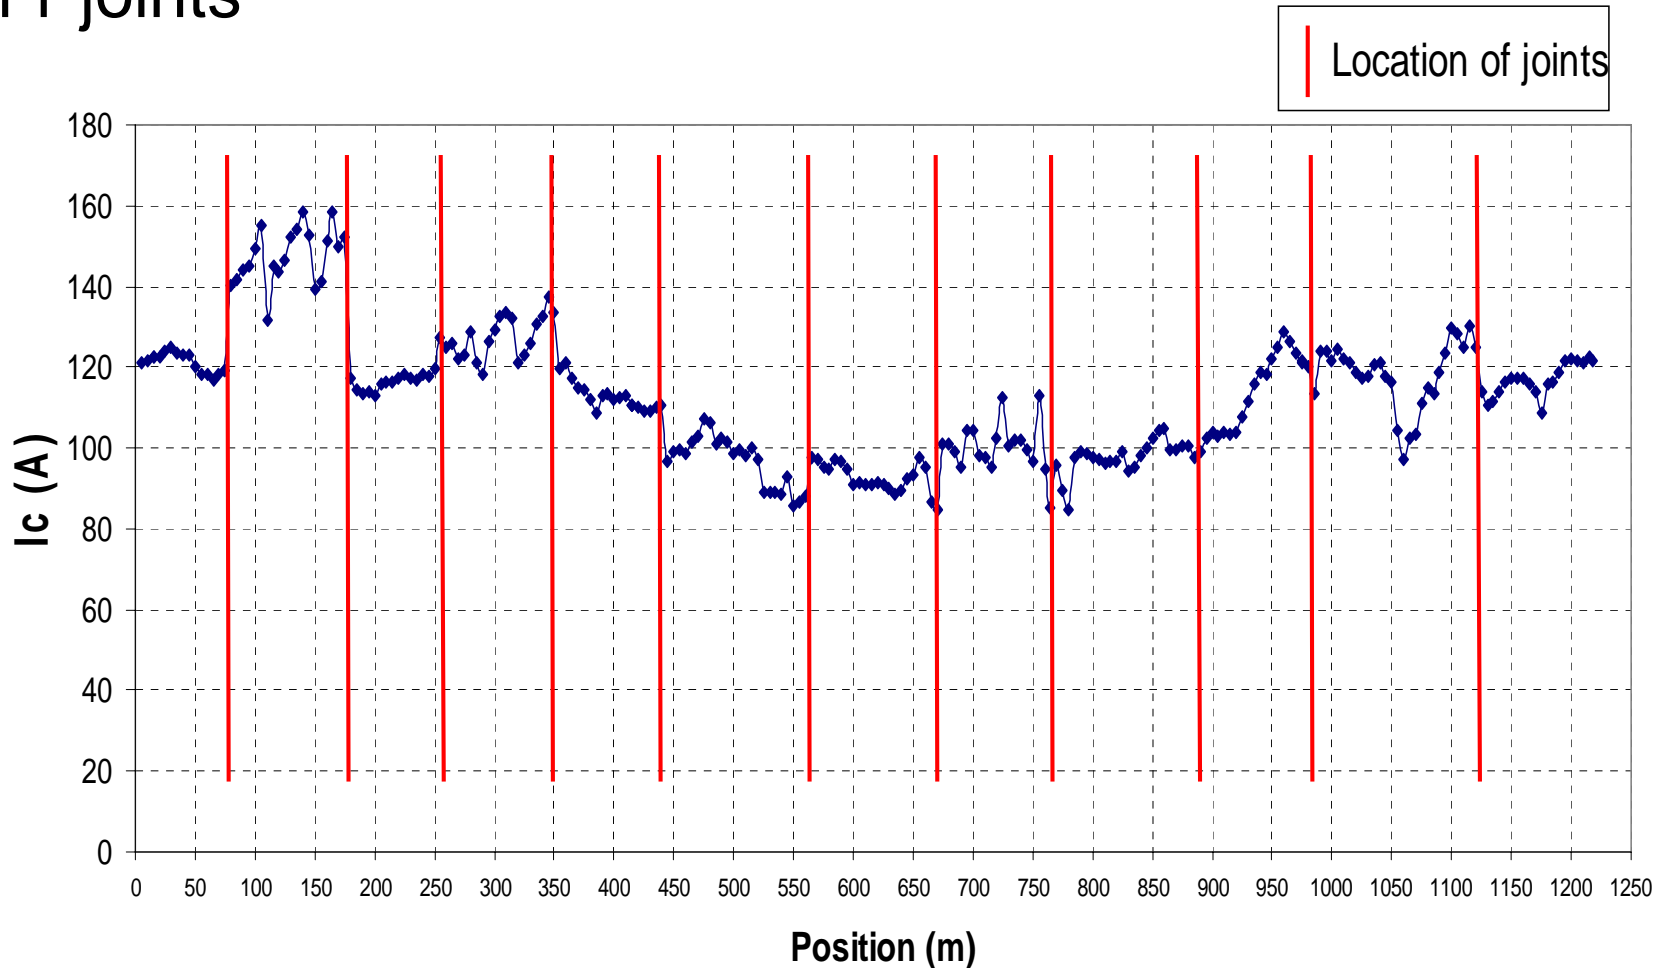
Ic measured every 5 meters over 1,218 m of wire with 11 joints

Arrangement of the 12 segments along the length was decided based on communication with customer so that the Ic profile would fit the coil winding requirements

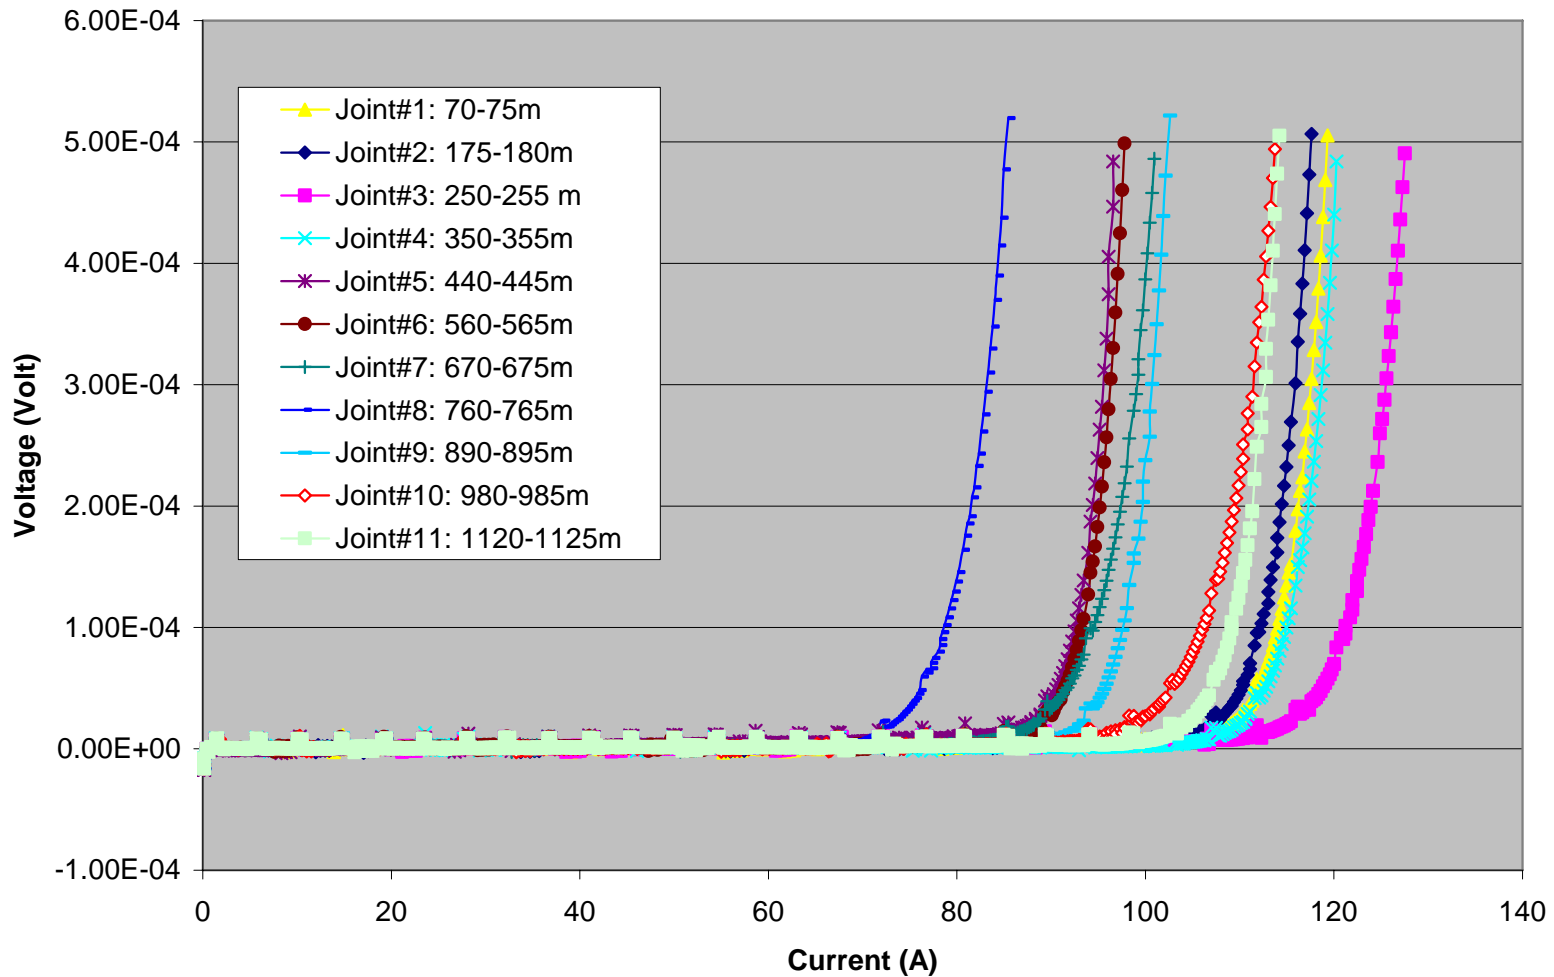
I-V curves of the 11 sections containing the joints

All 11 joints show smooth transition at their respective I_c

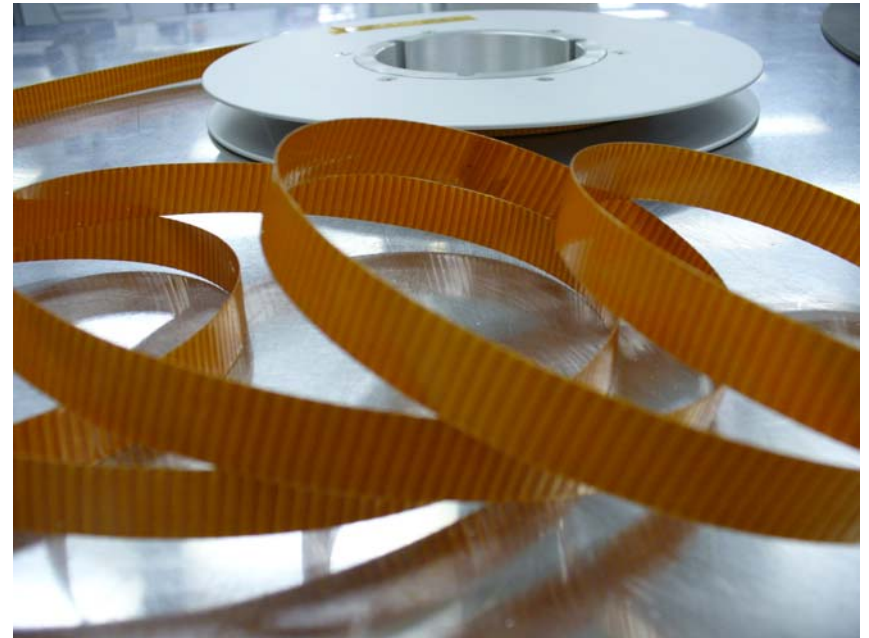
- Several customers, primarily for coil applications, required insulated 2G wire
- After evaluating a number of vendors, we procured a system for in-house fabrication of insulated wire
- System in place and being used for both 12 and 4 mm wide wire

- Preliminary test showed no breakdown at 1000 V with 0.0025 mm polyimide film
- Deliveries of insulated wire already being made.
